UNITED STATES
NUCLEAR REGULATORY COMMISSION
OFFICE OF NUCLEAR MATERIAL SAFETY AND SAFEGUARDS
WASHINGTON, D.C. 20555-0001

November 20, 2001

NRC INFORMATION NOTICE 2001-08, SUPPLEMENT 2: UPDATE ON RADIATION
THERAPY OVEREXPOSURES IN
PANAMA

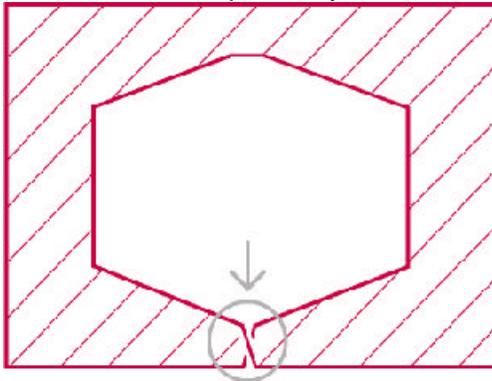
Fig. 1: Incorrect crossing block outline

In BEV, regardless of the direction in which the block is entered or the shape of the block, when the block outline crosses itself (see Fig 1, left) an improper block is created (i.e. not a true polygon.)

These improper blocks will produce substantially higher values (50 to 500% for MU or TIME-ON) than what one would expect by partially blocking an open field.

A filter program which automatically rejects an improper data entry sequence as an unacceptable outline, on the basis that it is not a true polygon, has been developed and is currently being tested. Once the project is complete, Multidata will make this program available to all customers in the form of an easy to install update. It is expected that this safeguard program will be compatible with any software version in use.

To assure that data entry defining an aperture shape is correct, one should use two blocks (Fig 4). Note that outlines of different blocks may overlap; however, if only one block is used, it is essential to verify that the block outline does not cross itself (Fig 3).

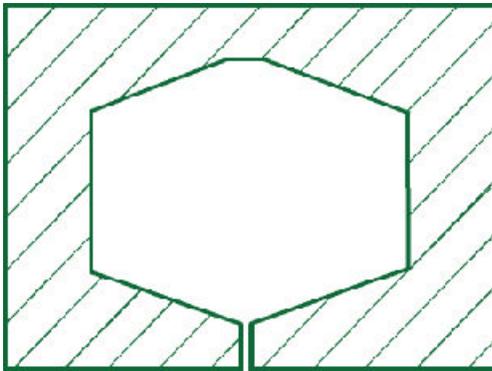
Fig. 3: Safe aperture definition with a single continuous line

Whenever this solid line is present, the data entered and plan results should be verified to determine that the results are valid and as expected. Please note that some properly entered blocks, including those that extend over three sides of the field (Fig 3), will also display this solid line.
